Repair instruction

Description: C200 Float arm HT

Part number: 23726

Version:	V1
Date:	19/01/2007
Tools required:	-

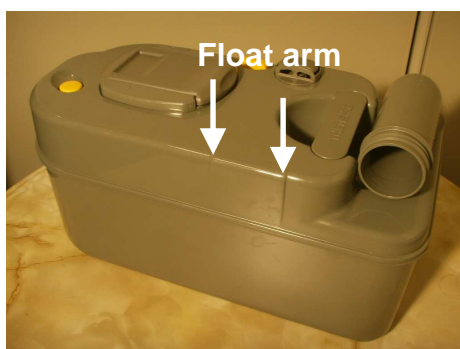
A

C200 holding tank.
See picture for
position of float arm.

Remove the float
arm.

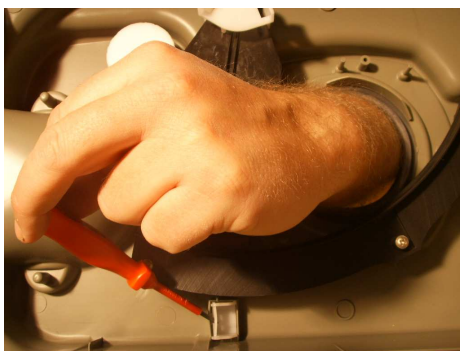
B

Make sure the float
arm retainer is
removed.

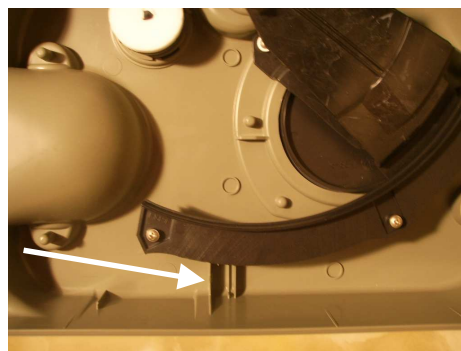
Float arm housing.

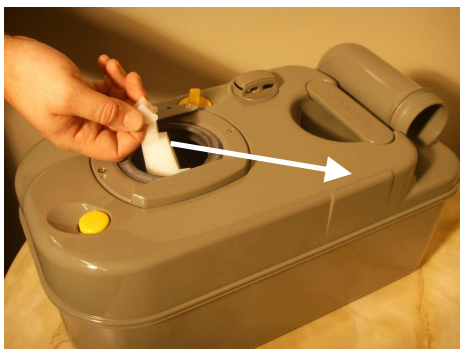
C

Place the new float
arm into the holding
tank with the magnet
side to the front.

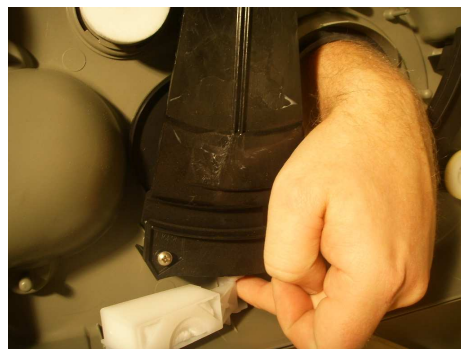
Press the float arm
into his position till
you hear a click.

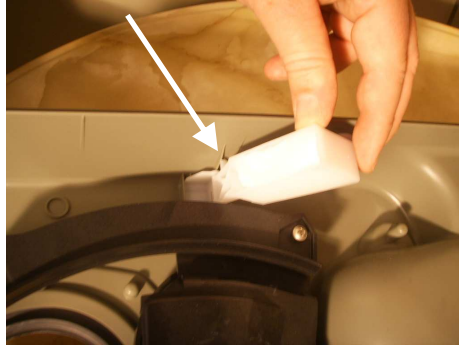
C

Move the float arm
over the rib.
